DEPARTMENT OF TRANSPORTATION

Quality Assurance and Source Inspection

Contract #: 04-0120F4Cty: SF/ALA Rte: 80 PM: 13.2/13.9File #: 69.28**WELDING INSPECTION REPORT****Resident Engineer:**Siegenthaler, Peter**Address:** 333 Burma Road**City:** Oakland, CA 94607**Report No:** WIR-023103**Date Inspected:** 06-Apr-2011**Project Name:** SAS Superstructure**OSM Arrival Time:** 700**Prime Contractor:** American Bridge/Fluor Enterprises, a JV**OSM Departure Time:** 1900**Contractor:** Zhenhua Port Machinery Company, Ltd (ZPMC), Changxing Island **Location:** Shanghai, China**CWI Name:** Gang Wei**CWI Present:** Yes No**Inspected CWI report:** Yes No N/A**Rod Oven in Use:** Yes No N/A**Electrode to specification:** Yes No N/A**Weld Procedures Followed:** Yes No N/A**Qualified Welders:** Yes No N/A**Verified Joint Fit-up:** Yes No N/A**Approved Drawings:** Yes No N/A**Approved WPS:** Yes No N/A**Delayed / Cancelled:** Yes No N/A**Bridge No:** 34-0006**Component:** OBG**Summary of Items Observed:**

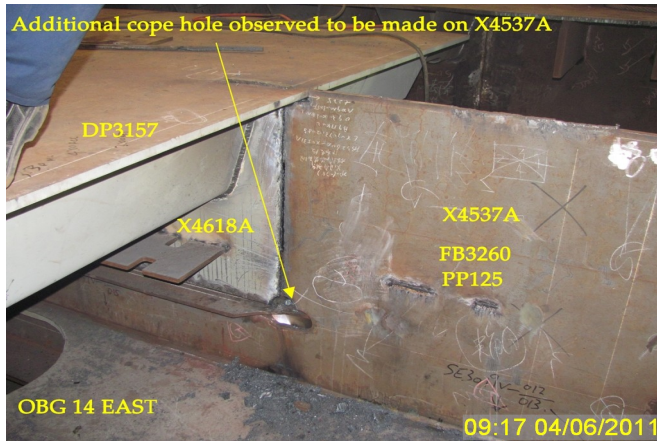
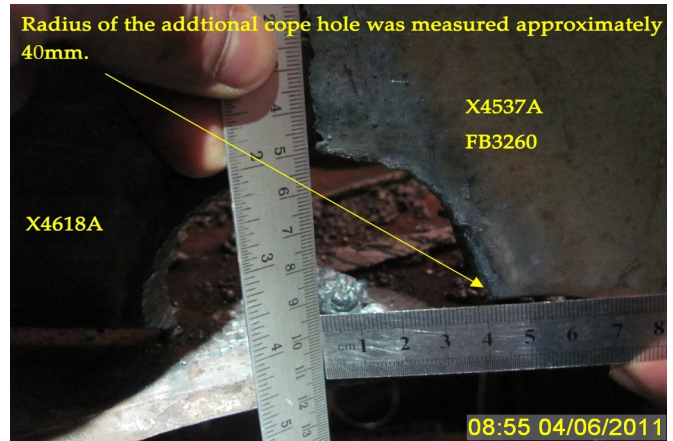
bay # 14, this Caltrans QA Inspector observed the additional cope hole approximately radius (R40) is to be made on X4537A (see attached photo). As per drawing, cope hole is to be provided as shown in detail 531S (of Drawing: SD531) on X4537A of Floor Beam (FB3260). X4537 is designated as Seismic Performance Critical Material (SPCM). Incident report was issued. See attached photographs for additional detail.
